Tunnel testing menace in Hydropower Projects continues

A fact-finding report on the recent hazards: 180MW Bajoli Holi Hydropower Project in Bharmour Tehsil, Chamba, Himachal Pradesh

January 2022

Himdhara Environment Research and Action Collective

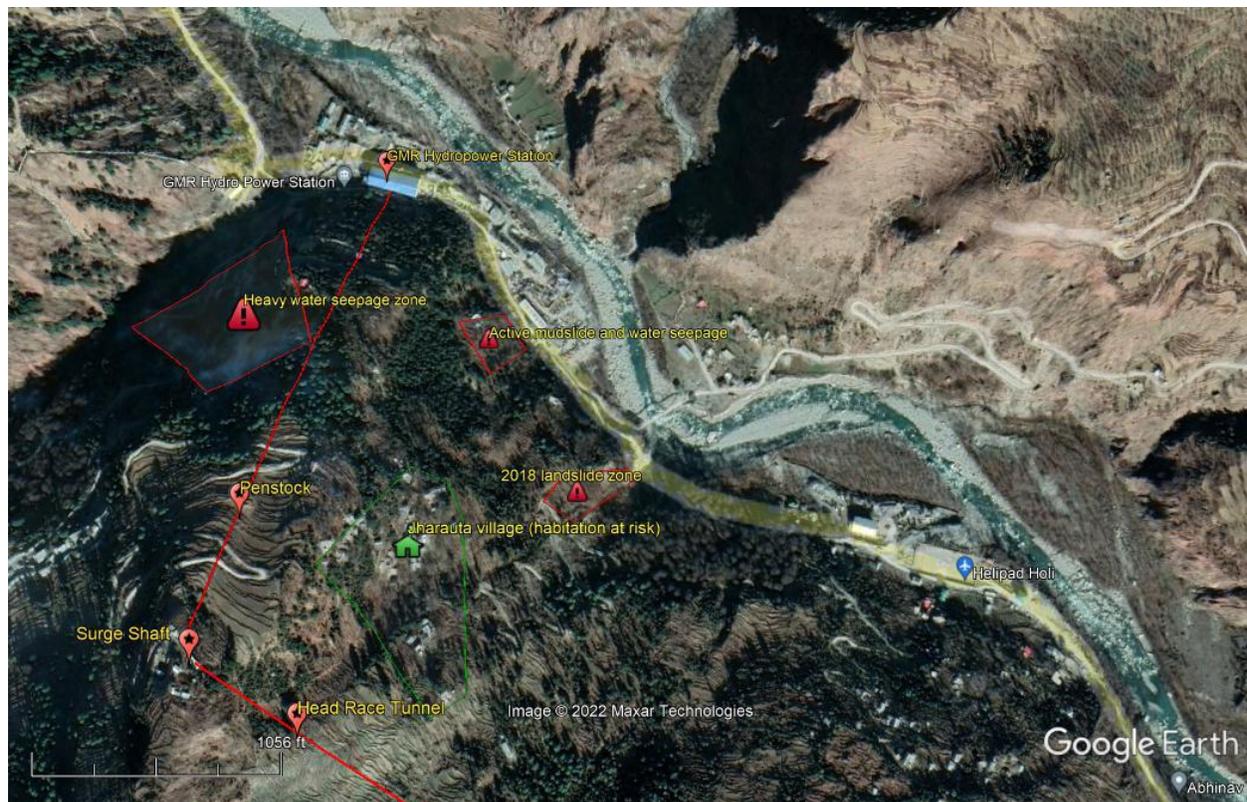
Bajoli Holi Power Station location along with left (populated) and right (barren) banks of Ravi; polygons depicting current mudslides due to water seepage from tunnel testing

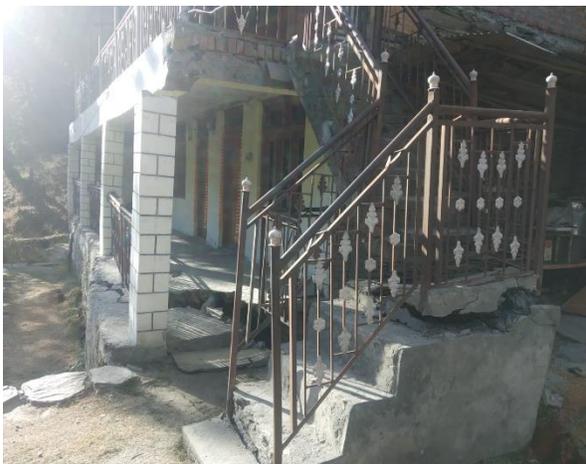
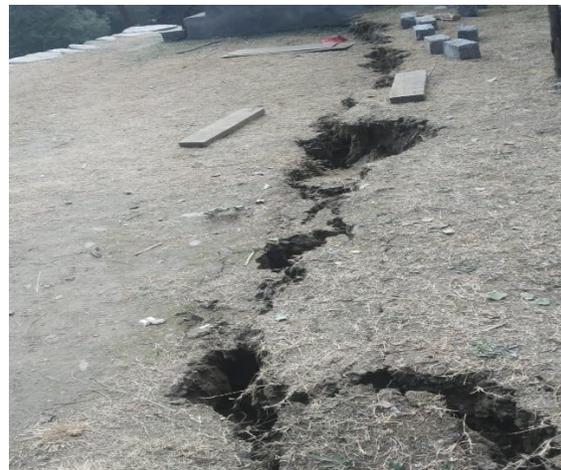
- On 22nd December the seepage started at the root of the village near the Holi-Chamba Road (State Highway), by this day three houses had started reporting appearing of massive cracks around the house and also in the walls. These included Chain Singh, Saini Ram and Jodha Ram, who were subsequently shifted to temporary quarters nearby on and after 31st December, 2021. [Savitri Devi W/o Chain Singh, was the first to vacate house and shifted on temporary quarters along with their livestock in nearby colony areas.](#)

Images from Jharauta village (Ward. No 4) is most affected and under continuous risk due recent water seepage and cracks on property. As informed, the residents of Jharauta (40 families), Ward No. 4 of Holi Panchayat noticed the following in the area from the day the testing work was initiated:

Cracks on houses/land of three families in Ward No. 4 Jharauta, with commencing of tunnel testing after 19th December

1. Immediate stopping of Tunnel Testing until the faults are repaired and risk preventive measures are put into place by GMR company management
2. State Dam Safety Organization of HP to investigate the matter at hand in urgent basis with on-ground visits

6. Comprehensive scientific (geological) assessment be carried out to assess the causes and extent of the seepages, cracks and landslides. This report has to be made public – with the people of the affected area. No testing work should start before this.

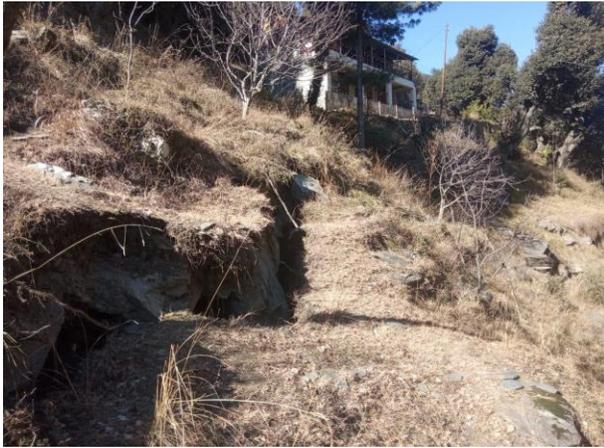
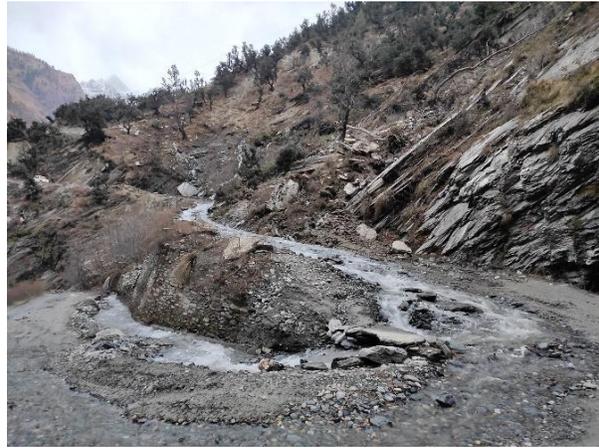
- On the night of the 19th December 2021, the villagers in Jharauta first noticed that the seepages near 'Pan kud' near the local deity Sati temple which is a forest area. 'The seepage amount at the time was not much', the women reported but as the days passed it kept increasing'. The news from staff of the project was that the tunnel testing for the project had been started but there was no formal notice about the same. The next day the local media and local panchayat and block representatives were informed about this.

Large cracks on public/private land and heavy water seepage below tunnel site on 19th December 2021

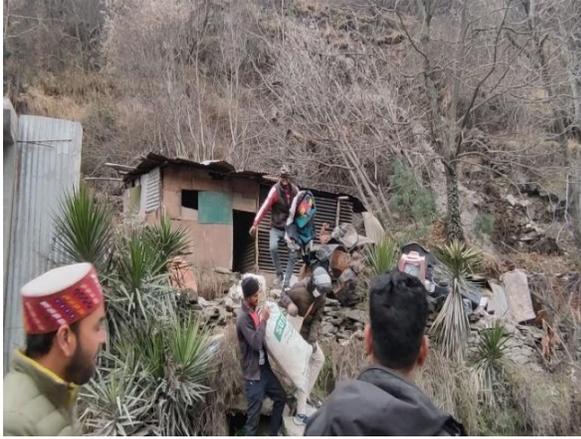
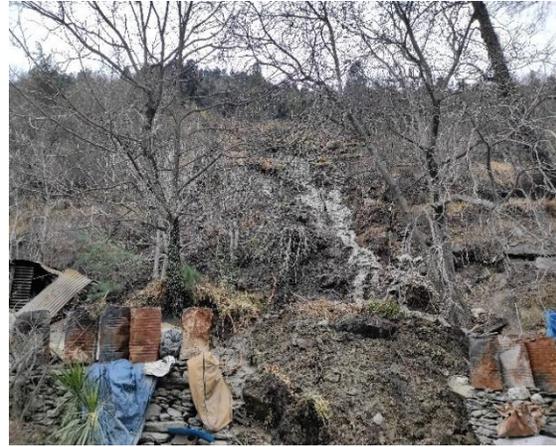
Recent mudslides and affected residential sheds due to water seepage on 3rd January 2022

1. The entire area below the tunnel testing site (including Jharauta village and Bajoli Holi road nearby power station) is under grave danger from landslides. Cases of crack in houses and private/public lands are prevalent in the region and shows the fragility of underlying geological strata. **A comprehensive scientific study from reliable and competent research agencies is necessary to avoid life threatening hazards in the area.**
